# Laxton & Moorhouse Parish Council

**Report author:** David Sheard    **Report to** Parish Council- Flooding Working Group    **Date:** 14th November 2023    **Decision Required?** Starting point for discussion.

**Subject: Flooding and Drainage Strategy**

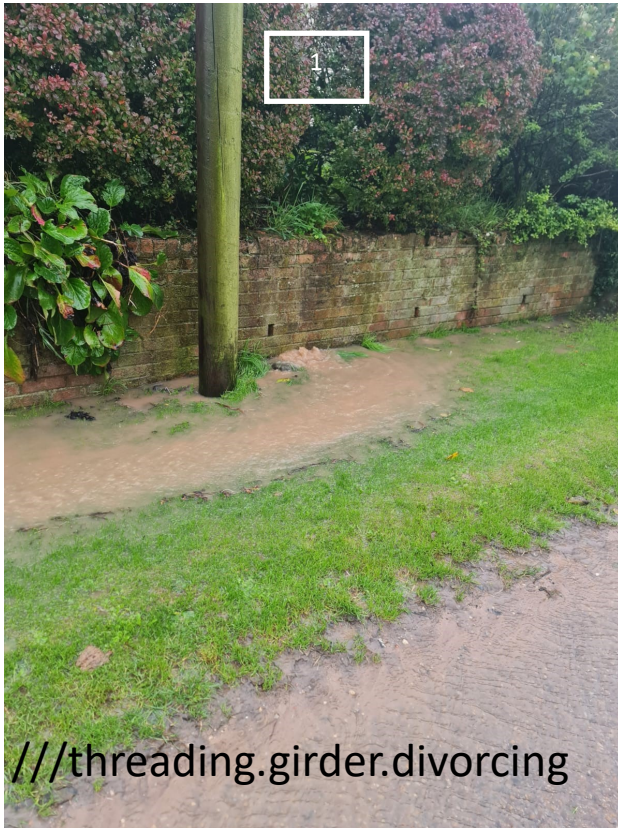
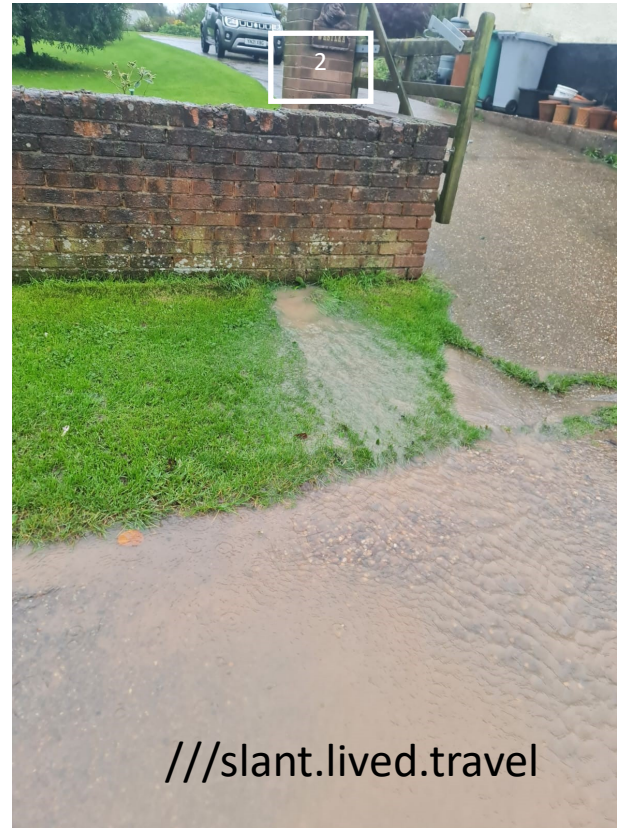
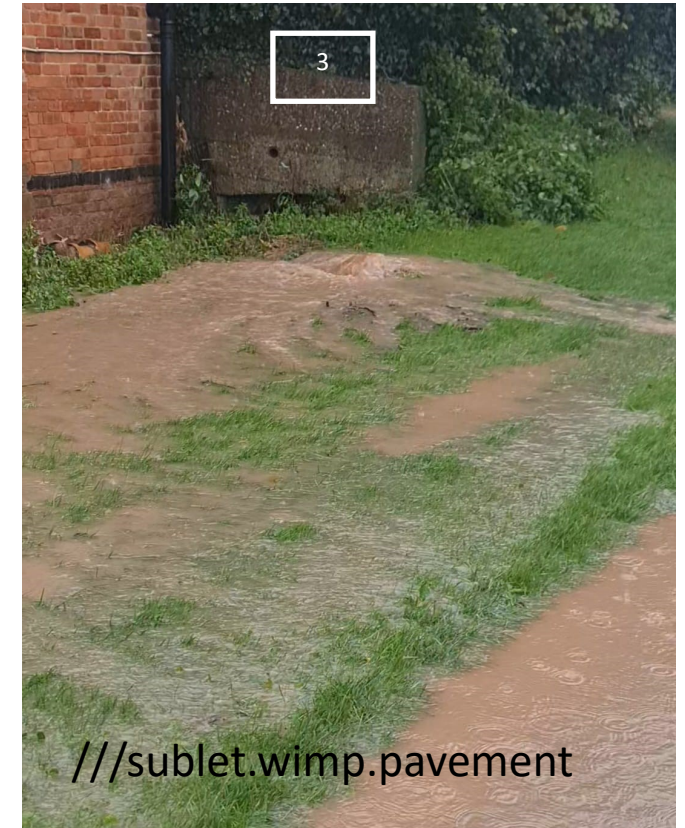
## Town End

Water emerging out of the verge, in 2 places, adjacent to Westlea, Town End.

Water emerging out of the verge, adjacent to Top Farm, Town End

**Problem:** Blockage of underground culvert forcing water out through weak points, back onto the highway adding to the surface water flooding further down the road.

**Solution:** Inspection of the underground culvert, removal of any blockages and repair as necessary

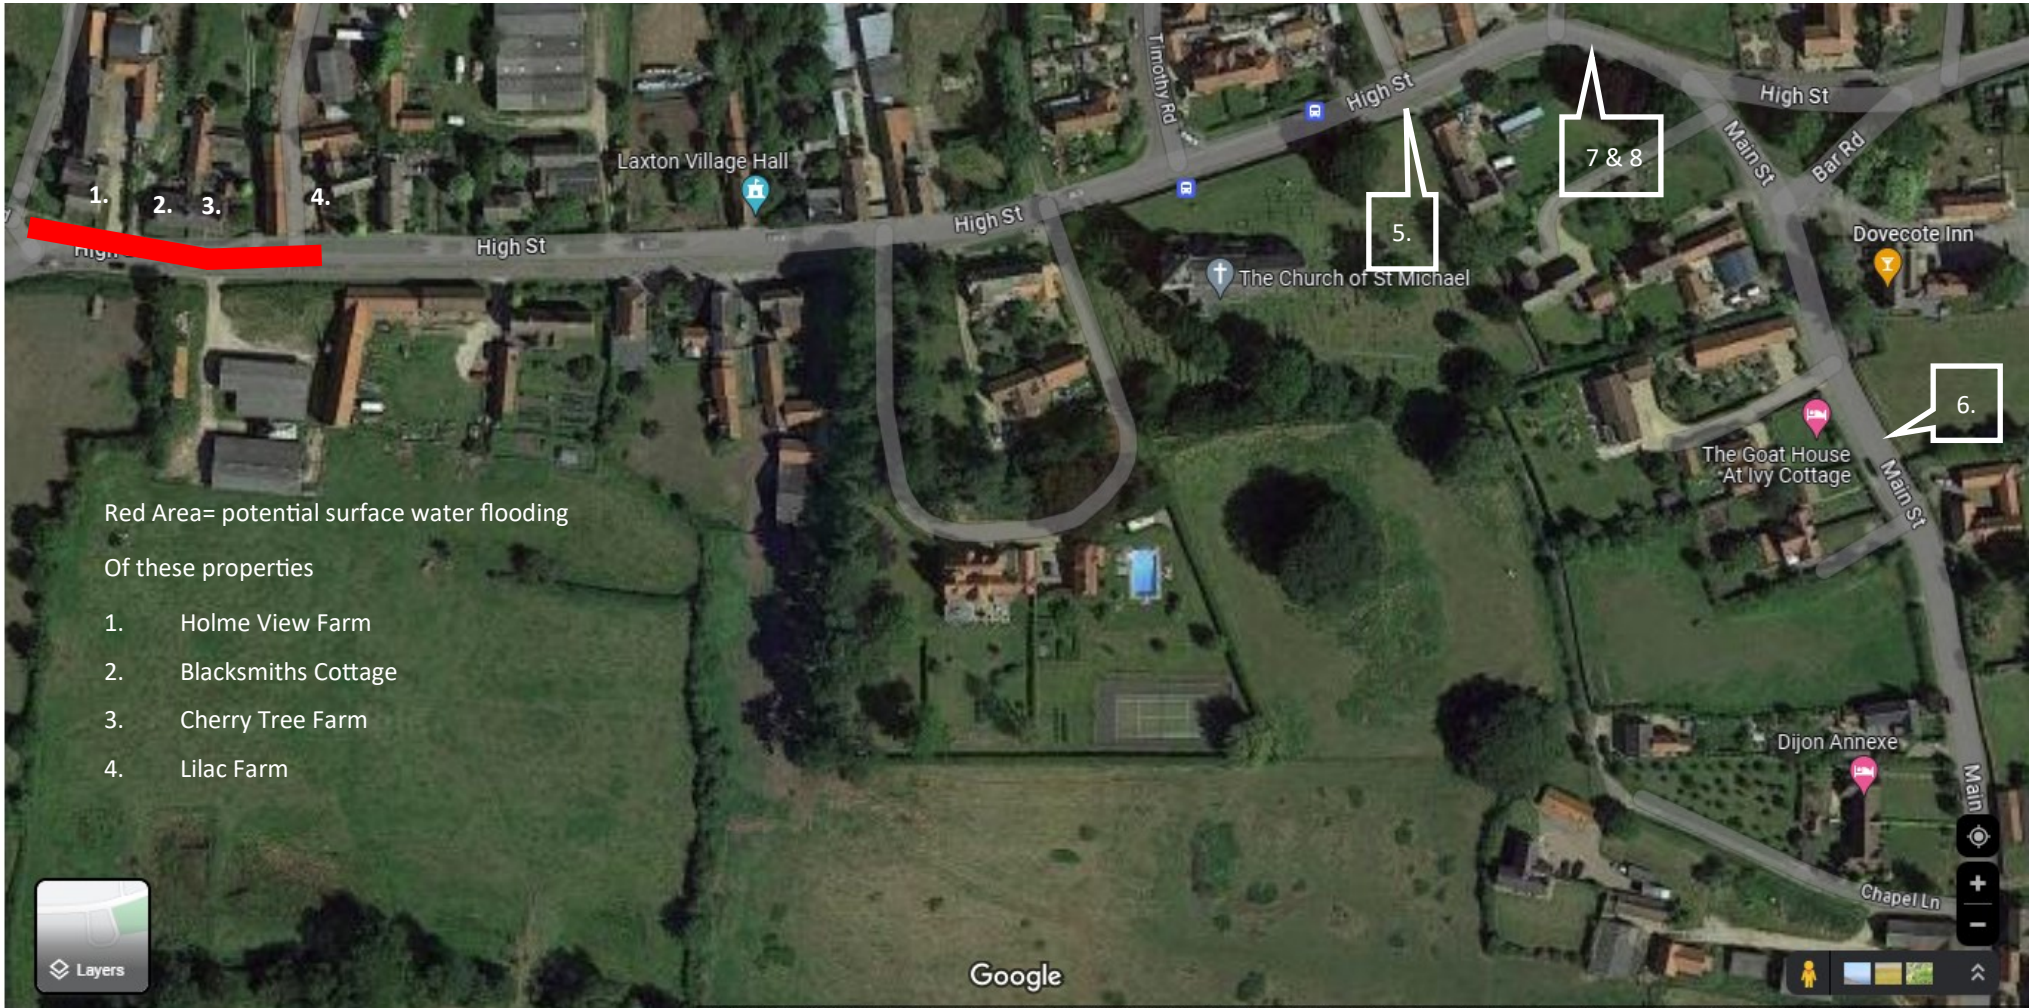
Red Area= potential surface water flooding

Of these properties

1. Holme View Farm
2. Blacksmiths Cottage
3. Cherry Tree Farm
4. Lilac Farm

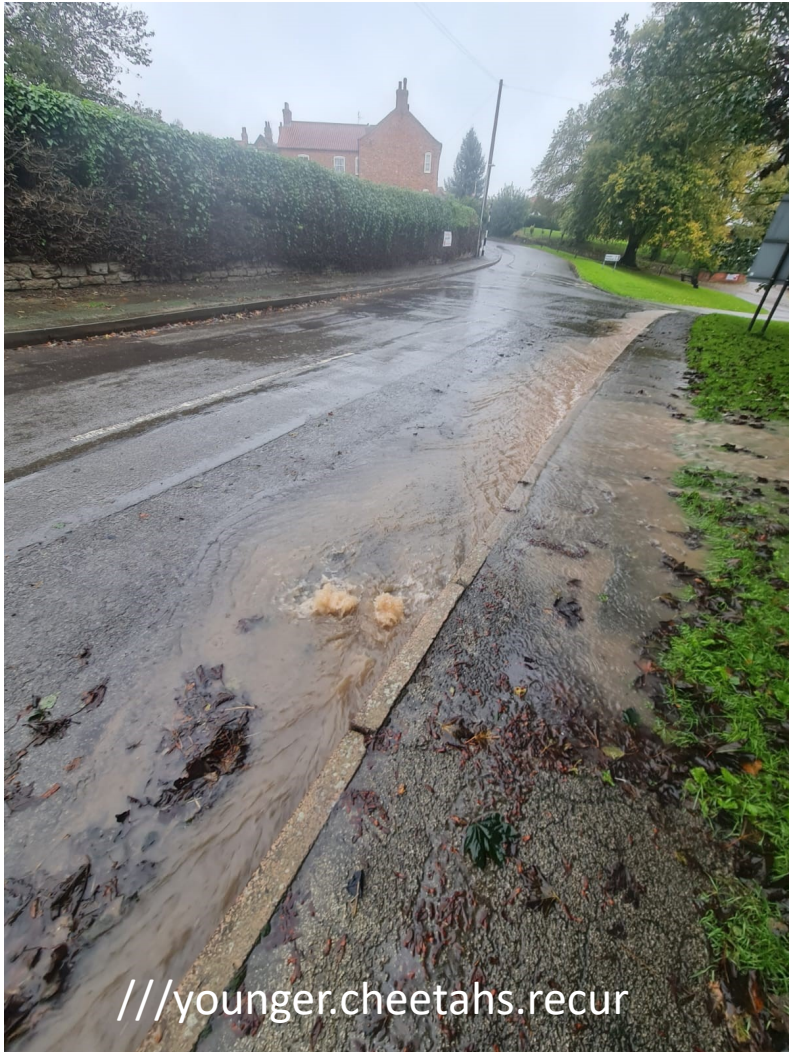
## Crosshill

**Problem:** Blockage of underground culvert forcing water out through weak points, back onto the highway adding to the surface water flooding further down the road.

**Solution:** Inspection of the underground culvert, removal of any blockages and repair as necessary

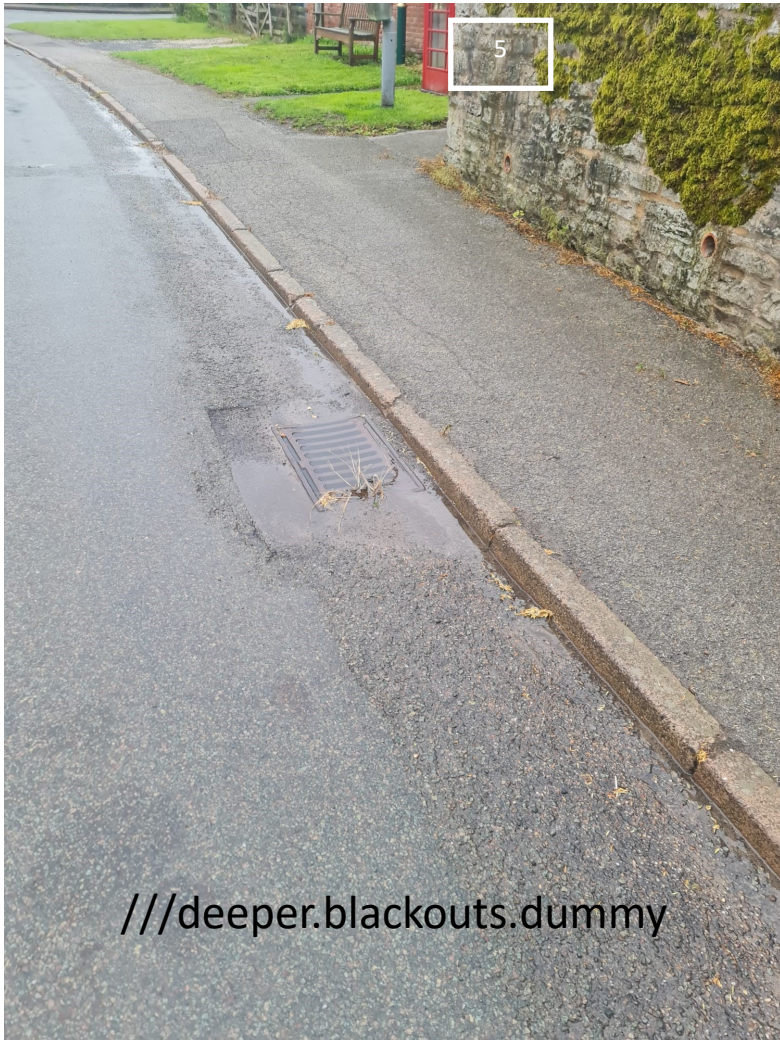
## High Street

Blocked drain requires clearing

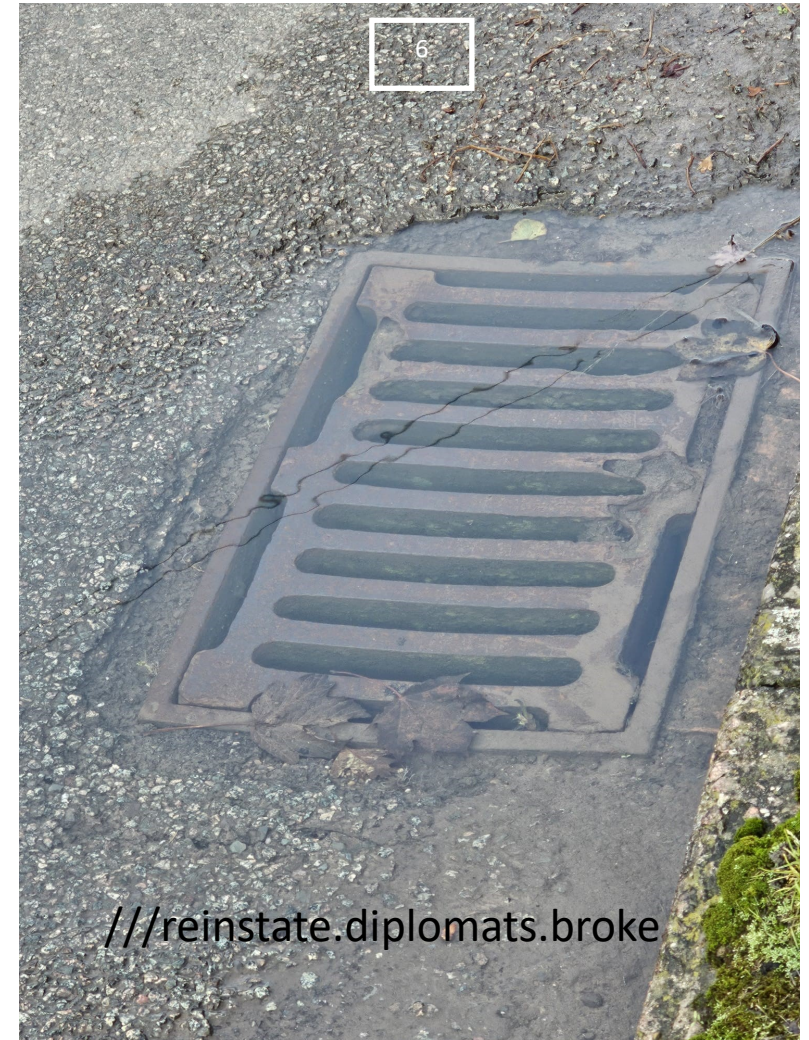
## Main Street

Blocked drain requires clearing

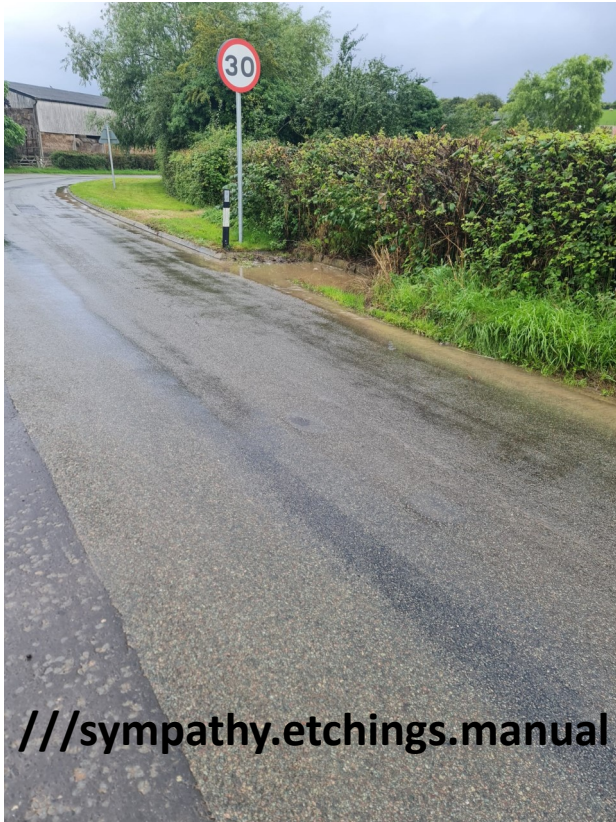
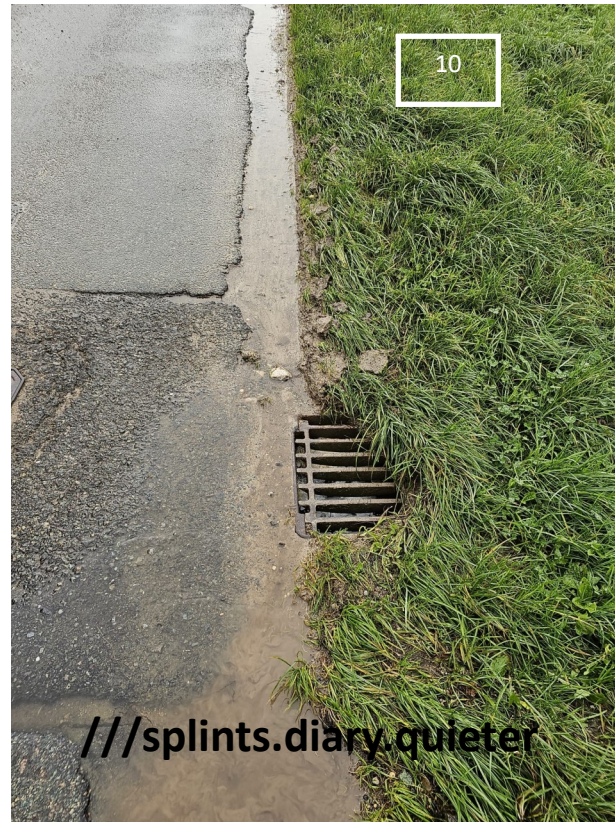
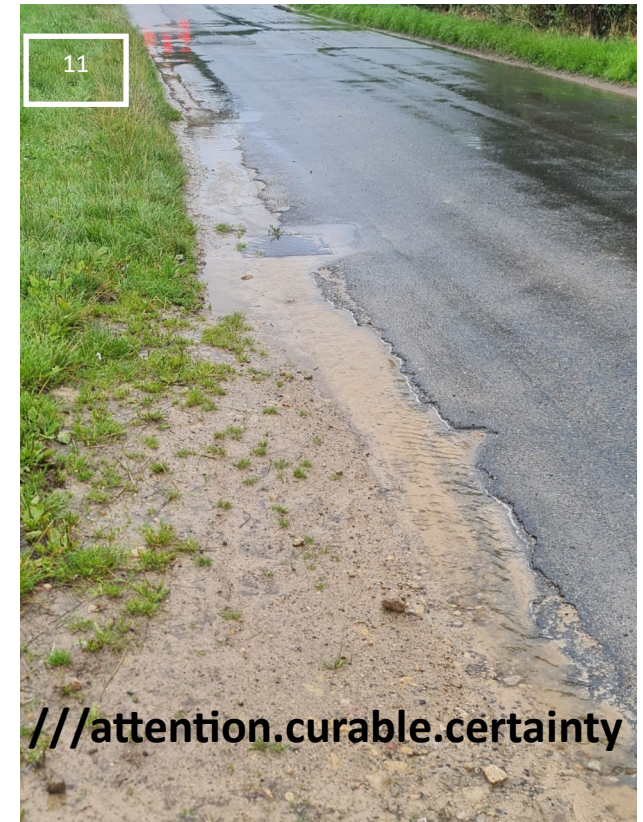
## Kneesall Road

Blocked drains requiring clearing to allow water to enter the drainage system and to reduce the impact of surface water flooding on adjacent houses.

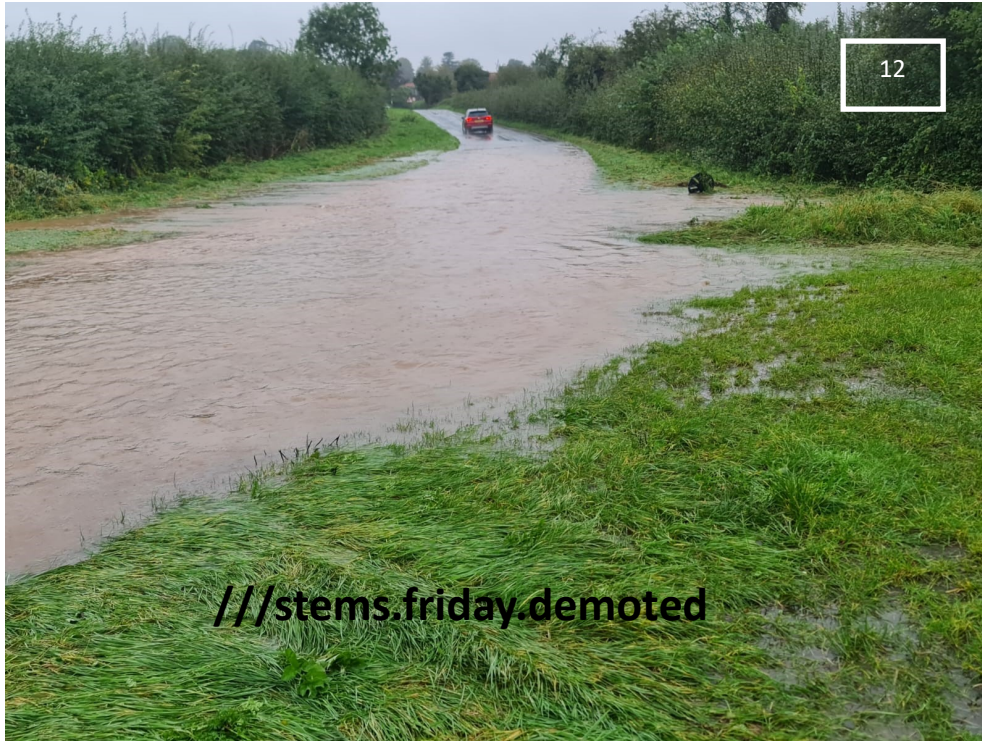
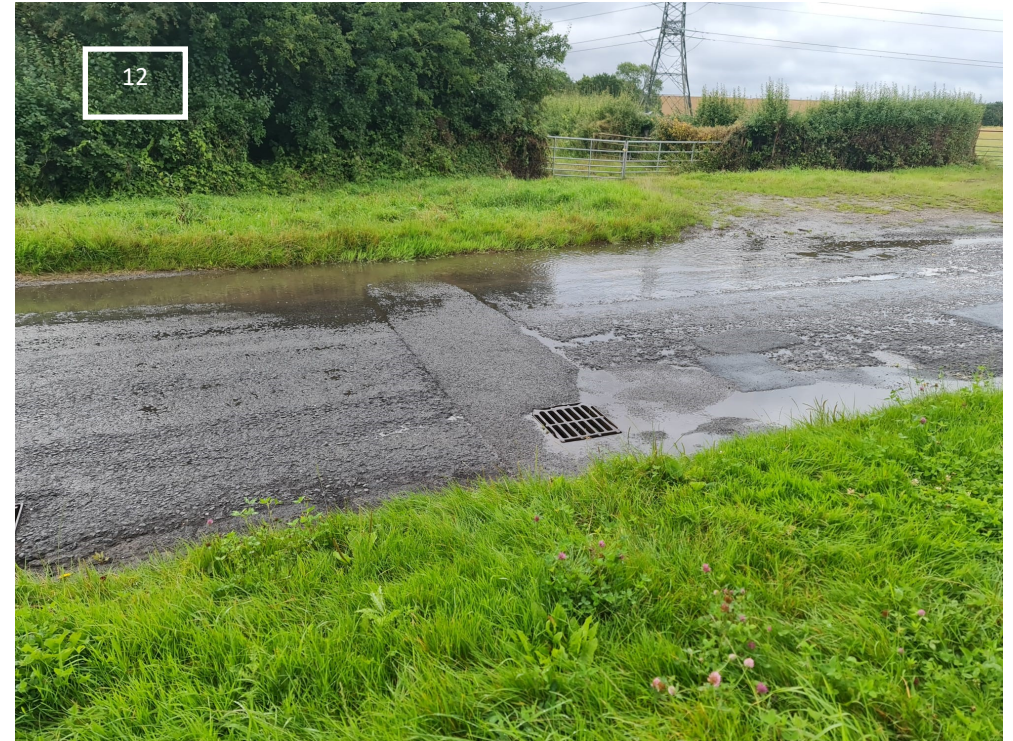
## Kneesall Road

**Problem:** Lack of drainage on the road causes pooling of water on the road surface. Water overflows from the dike, crossing the road from Approx 300 mm deep in heavy rain.

**Solution:** Channel cut on the grass verge to allow the surface water to enter the dike, and/or create another drain on the other side of the road( the lower side).
